Motorola Solutions Technical Notification (MTN)

TITLE: APX/PCR RSM Cable Jacket separation/fraying exposing internal wires

TECHNOLOGY: Accessory - APX/PCR Remote Speaker Microphones

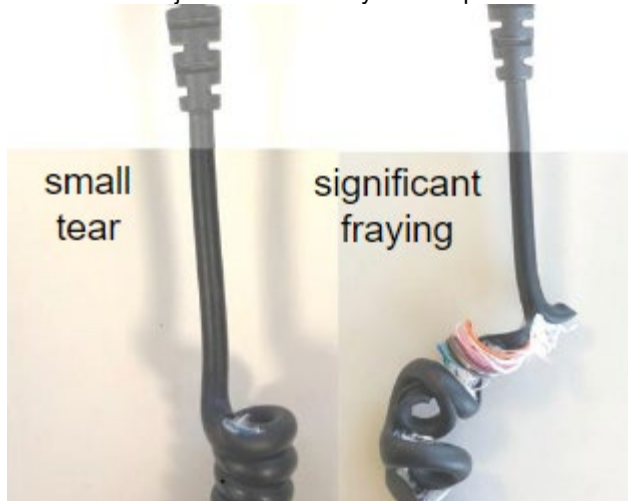
The RSM cable jacket tears or frays and exposes the internal wires. See the example picture below..

Cable tear or fray is a condition in which:

- the RSM cable black outer jacket develops frays that get worse with use
- the inner cable contents become visible
- typically occurs at RSM head or radio connector (GCAI) end or both, but can also occur in cable middle section.

Motorola will extend the warranty to 2 years (1 year beyond the standard RSM warranty period) for units that exhibit the cable fraying issue.

Only units exhibiting fraying symptoms will be replaced under this MTN - returned units will be verified for failure symptom upon receipt. The Replacement of RSM can be obtained by calling Motorola AAD (Parts Dept) at 1-800-422-4210; prompt 1.

The following lists show which model RSM is to be used for replacement with the larger coil diameter solution.

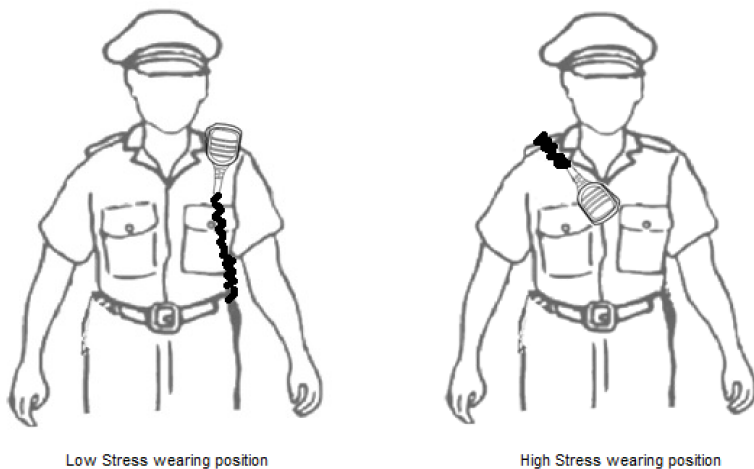
Motorola RSM cable jacket material was changed in 2013 in order to comply with changes in global environmental material regulations. In the RSM cable application, the compliant jacket material has demonstrated a greater susceptibility to tearing at points of stress induced when the coil is elongated or stretched. How the RSM is positioned on the body (i.e across the back and over the shoulder vs. along front of the body - see picture) directly affects potential induced coil stress.

Susceptibility to the cable jacket tear phenomenon has been significantly reduced by increasing the coil diameter which effectively reduces coil cord stress. Motorola strongly recommends RSM users to dress the RSM coil section of the cord in such a way that it does not get caught on uniform accessories and equipment or equipment worn on the person for optimal RSM service life.
